# **Exhibit B**

**Work Order Details**

Work Order Number	469115
Work Order Type	Sewer Backup Investigation
Location	3395 LAKEMEADOW CT, COLETP
Requested by:	LINDA LEIST
Telephone - Home	[REDACTED]
Telephone - Work	.
Customer e-mail	
Comments	<p>Comments #1:  (Copied from Service Request 61321): "Caller: LEIST, LINDA:  Q: Where is the Sewer Backup Occuring?  A: Inside Building  Q: What is the lowest floor of the building that has a Sewer Backup?  A: Basement / Lower Level  Q: Are you experiencing a backup now?  A: YES  Q: How is the backup primarily entering the building?  A: Floor Drain  Q: Would you like to request a specific 4-hour window for our response service?  A: NO  Q: Is this building protected by an MSD-owned pumping system?  A: No  Q: What type of building is this?  A: Single-Family Home  Q: How deep was the water/sewage at its deepest point?  A: Puddle around floor drain  Q: Is there insurance in place to cover this problem?  A: Unsure  Q: Please enter the Date this back up began.  A: 3/24/2023"</p>

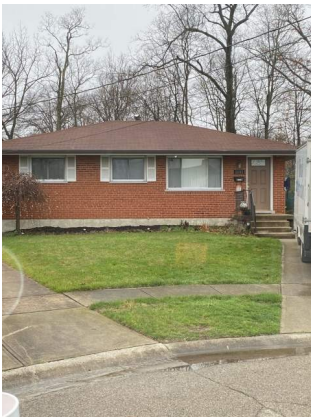
Photo of House

Is the property backed up now? Yes

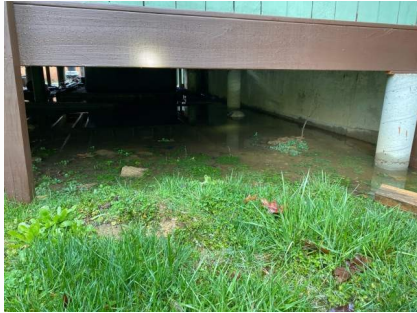
Rear of building yard is underwater

Backyard

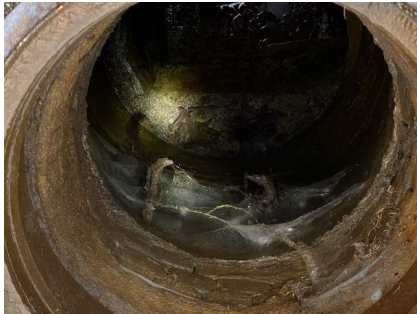
No sign of surcharge
